# GRASSLAND DEVELOPMENT BY EROSION CONTROL ON HILL SLOPE USING MULTI FUNCTION FILTER AND VEGETATION

M.S. Alam<sup>1</sup> and K. Hosoyamada<sup>2</sup>

<sup>1</sup>The United Graduate School of Agricultural Science, Kagoshima University, Japan

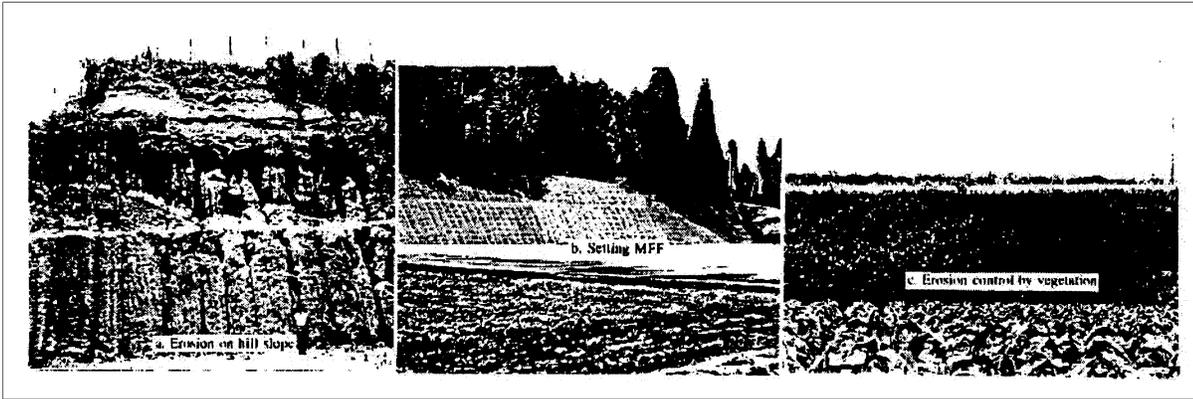
**Figure 1**

Steps to control soil erosion on hill slope using multi function filter and vegetation.

First of all it is necessary to get the hill slope in plain surface condition by cutting and filling at a certain gradient. In the case of high hills it is advisable to make terraces. After completion of slope surface leveling

NWF was placed next to the surface of the soil with vegetation seed at a certain rate, fertilizer may also be used if sloping soil is not fertile enough to grow vegetation. A drainage outlet was constructed at the bottom of the slope to drain runoff flow. Different grass seeds viz. Kentucky 31 fescue, Creeping red fescue, Kentucky blue grass, White clover, Lespedeza bicolor and Lespedeza cuneata were applied at a certain rate as a summer vegetation. As winter vegetation Kentucky 31 fescue, Burmuda grass, Weeping love grass, Lespedeza bicolor were applied. Alfalfa and Oat was not planted for controlling soil erosion because the results are not well documented (Wollenhaupt, 1995).

There were four different hill sites of 576, 820, 1675 and 1320 m<sup>2</sup> of Hae No.1, Hae No.2 Tokya No.2 and Tokya No.3 respectively brought under cultivation in March, 1992. Five years after construction the vegetation in both Hae No. 1 and Hae No. 2 sites is in good condition, slope erosion and slope failure have not been observed and slope has been stable even under the successive heavy rainfall in the summer in 1993. In Tokya No. 2 and Tokya No. 3 there were high erodible soils named Shirasu; soil was exposed and vegetation seeds were gathered in some places, but the slope is still in good condition and no slope failure was recorded although heavy rainfall occurred. Fodder crops and vegetables are growing successfully every year continuously, as shown in Fig. 1. Before development of these four sites, it was not possible to grow any crop on these sites.
